Rethinking Pleshey Castle

New discoveries from old records

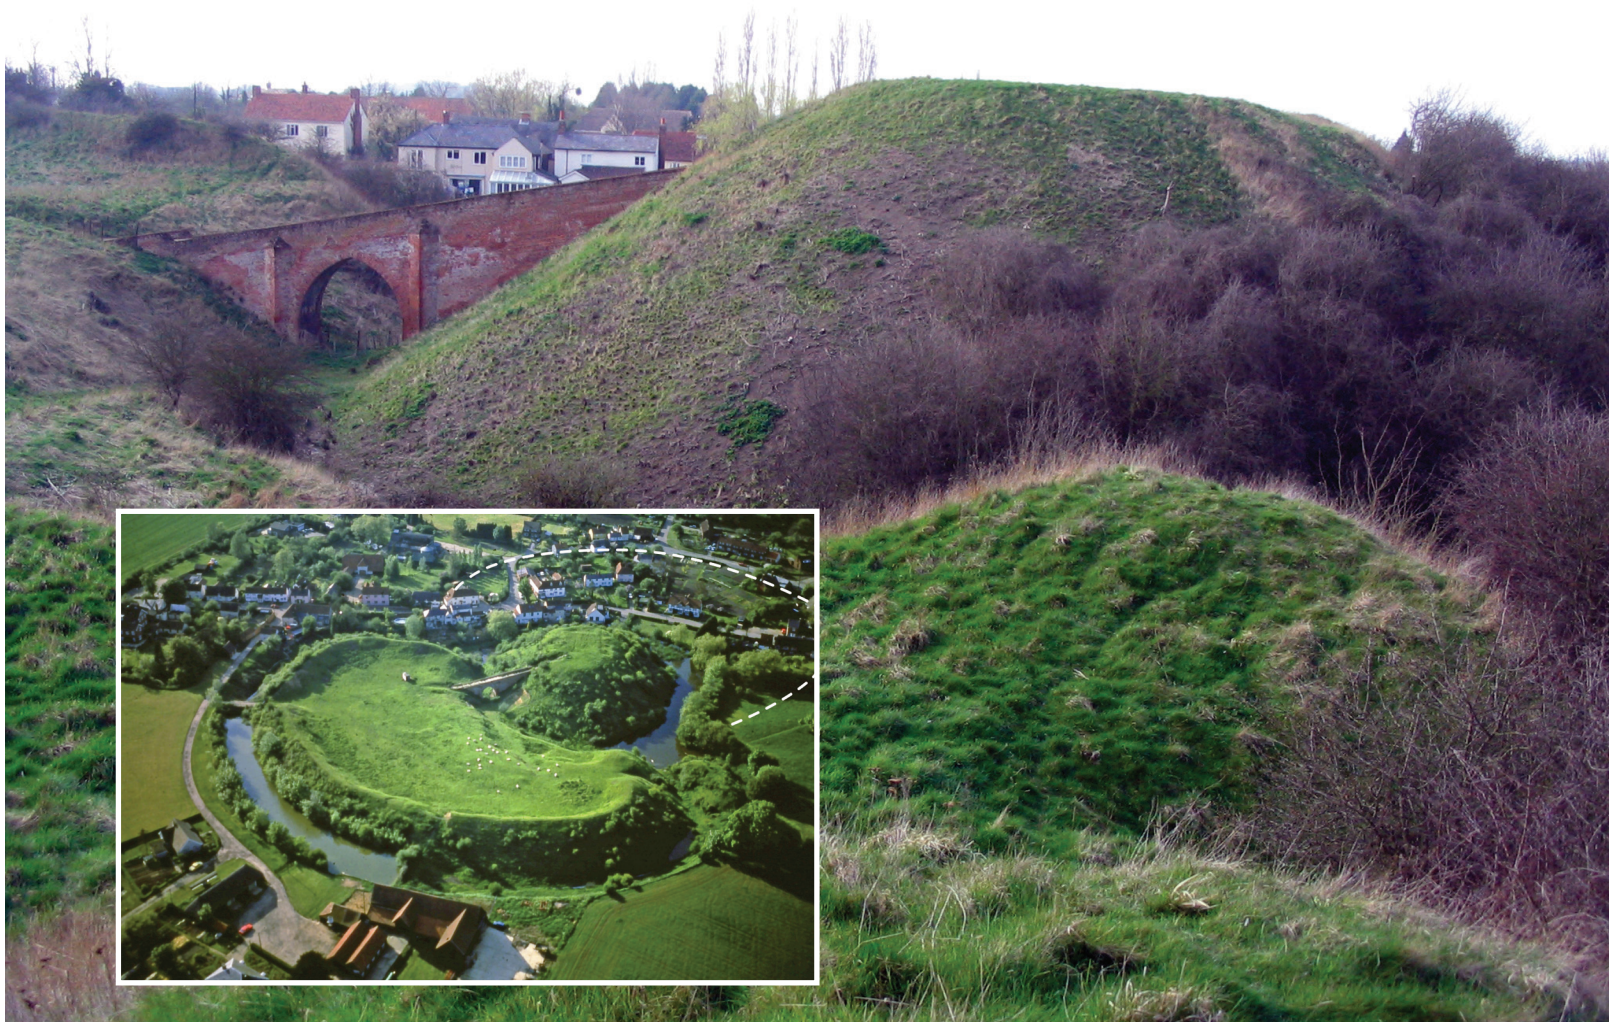
ABOVE & INSET

Overlooking the remains of Pleshey Castle in Essex. The aerial photo shows the motte and south bailey; the dashed white line marks the outline of the north bailey, while the medieval town enclosure bank can be seen top left.

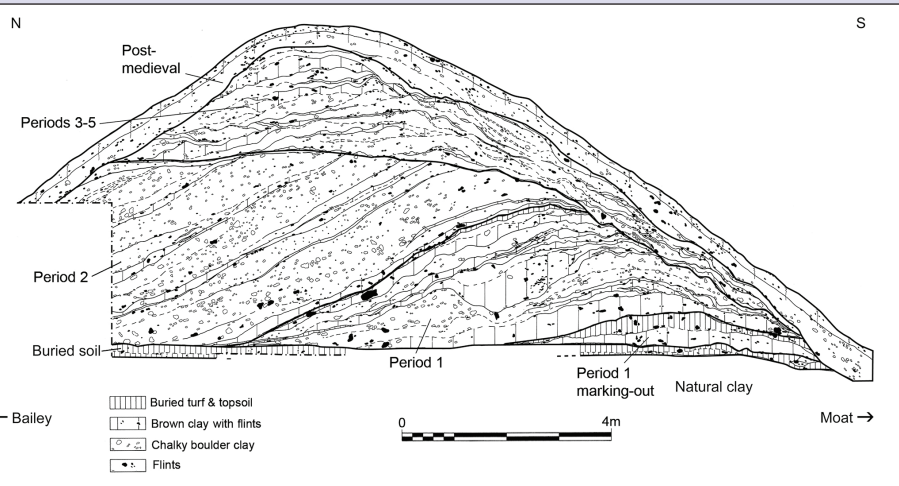
BELOW LEFT A section through the south bailey rampart shows how its earliest incarnation, as constructed c.1100 (Period 1), still survives at its base. Period 2 reflects the boundary's enlargement and refortification after 1167.

It is also becoming increasingly clear how the fortifications developed; Chelmsford Museums Service has been revisiting unpublished reports from an excavation that Steven Bassett undertook immediately to the south-east of the brick bridge in 1972-1981. Interestingly, a section that he recorded through the outer rampart confirms that the south bailey was also part of the original construction of the castle – that is, Pleshey had two baileys from its inception. Within this rampart (which was dated to the later 12th century by previous excavations, headed by Philip Rahtz, in 1959-1963), Bassett also found traces of a smaller, earlier rampart that had been built up in two stages, suggesting an initial temporary earthwork which was completed after a short interval.

the same plan as before. Bassett's excavation uncovered clear signs of a comprehensive clearing out of the moat during this period, and sections recorded by both Bassett and (earlier) Rahtz show the south bailey rampart being massively enlarged at the same time.

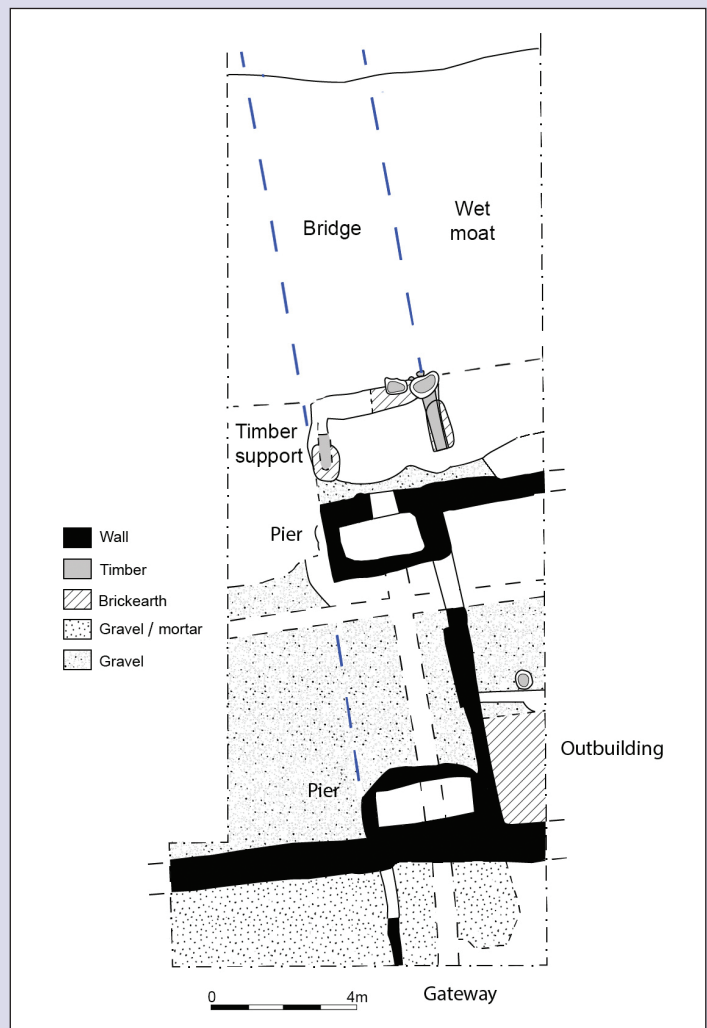
RIGHT At the south end of the timber bridge (its late 14th-century foundations are shown on this plan) was a gatehouse whose upper space has been identified as the 'Queen's chamber' described in building accounts.

bridges spanned the motte moat. Traces of these trestle structures were recorded by Bassett, as well as in a small trench excavated by Elizabeth and John Sellers. The final development of the south end of the bridge consisted of two stone pier bases. They would have supported box-frame timber uprights and, in front of these, a wooden structure holding the massive raked timbers that carried the central span of the bridge over the wet part of the moat.

Bassett's excavations also recorded at the south end of the bridge part of a stone-built gatehouse, whose

upper chamber can be identified as the Queen's chamber in the building accounts. The gateway and the room to its west, possibly a guard chamber, were surfaced in gravel and mortar, but material found in the demolition rubble indicates that the Queen's chamber above was much grander, with a floor of Penn-type decorated tiles, painted plastered walls, and leaded glazed windows.

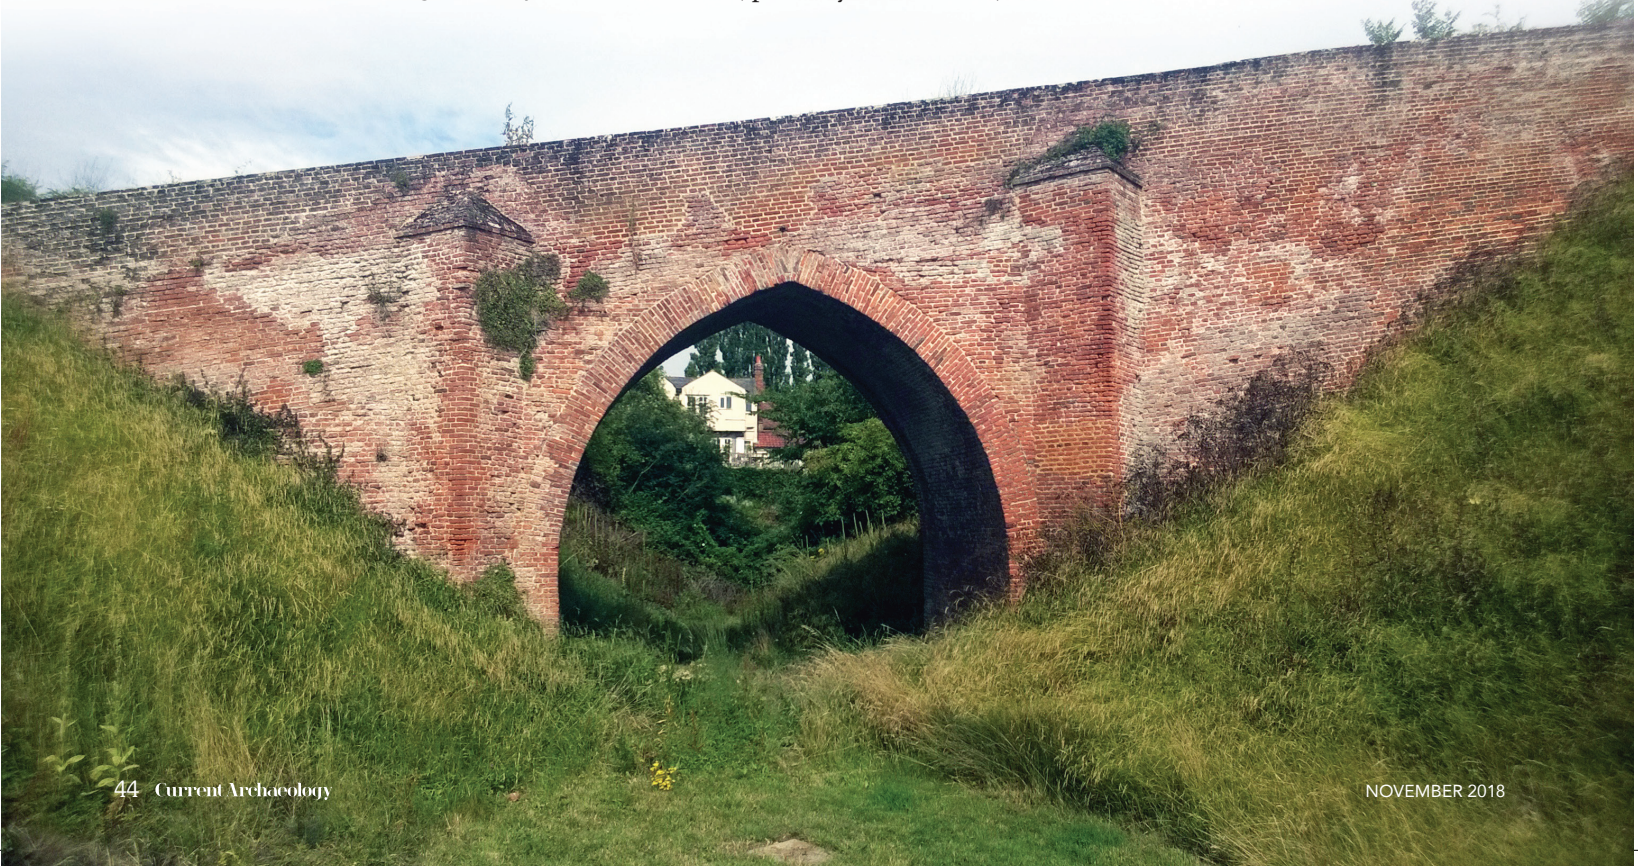
BELOW Most likely built in 1477-1480, this brick bridge is the only structure relating to Pleshey Castle still standing. It represents the culmination of the keep's final renovation, carried out on the orders of Margaret of Anjou.

The renovation of the keep was completed by building the brick bridge over the moat, probably in 1477-1480,

according to Pat Ryan's study of the building accounts. This was 20 years after the work on the keep itself – perhaps the works were delayed by the Wars of the Roses (1455-1487). The brick bridge is one of the earliest of its type in Europe and, with its wide span, was a very advanced design for its time. By the mid-16th century, though, the castle had become derelict, with the motte mound used as a rabbit warren. It was sold by Elizabeth I in 1559. Ironically, the brick bridge was preserved only because the Duchy of Lancaster surveyors recommended that it be retained to maintain access to the warren. Today, it stands as one of the few elements of the castle surviving above ground. Analysis of excavated evidence has enabled us to add much more colour to this picture, and to reconstruct Pleshey Castle's appearance once more. ■
