Archaeological Survey  
Ballintober Castle  
Ballintober, Co. Roscommon  
Ireland

RO027-048002-

Niall Brady

Castle Studies Trust  
2014 Grant award

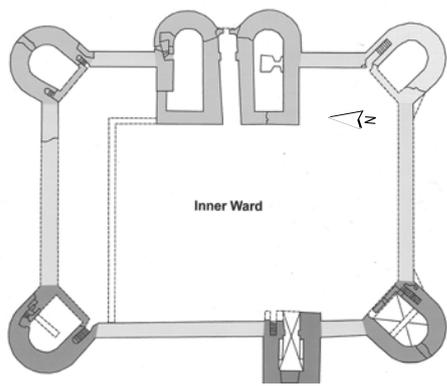
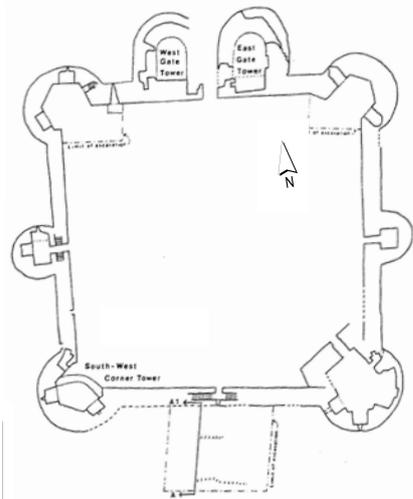
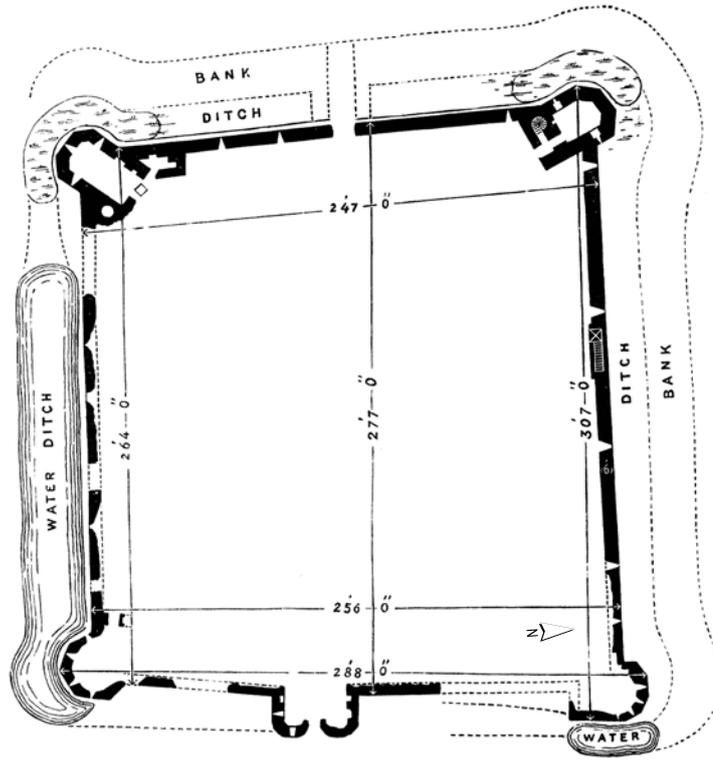
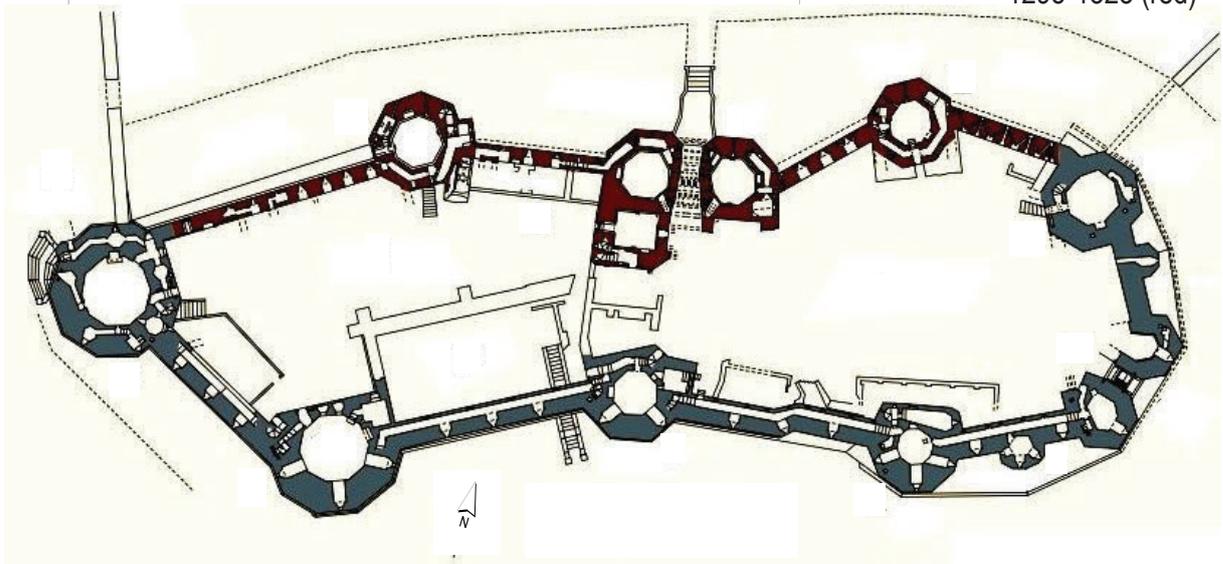
Figure 6: Comparative ground plans of keepless castles in Connacht and at Caernarvon

Roscommon Castle  
from 1269

Ballymote Castle  
from early 1300s

Ballintober Castle  
from early 1300s

Caernarvon Castle  
1283-1293 (blue)  
1295-1323 (red)

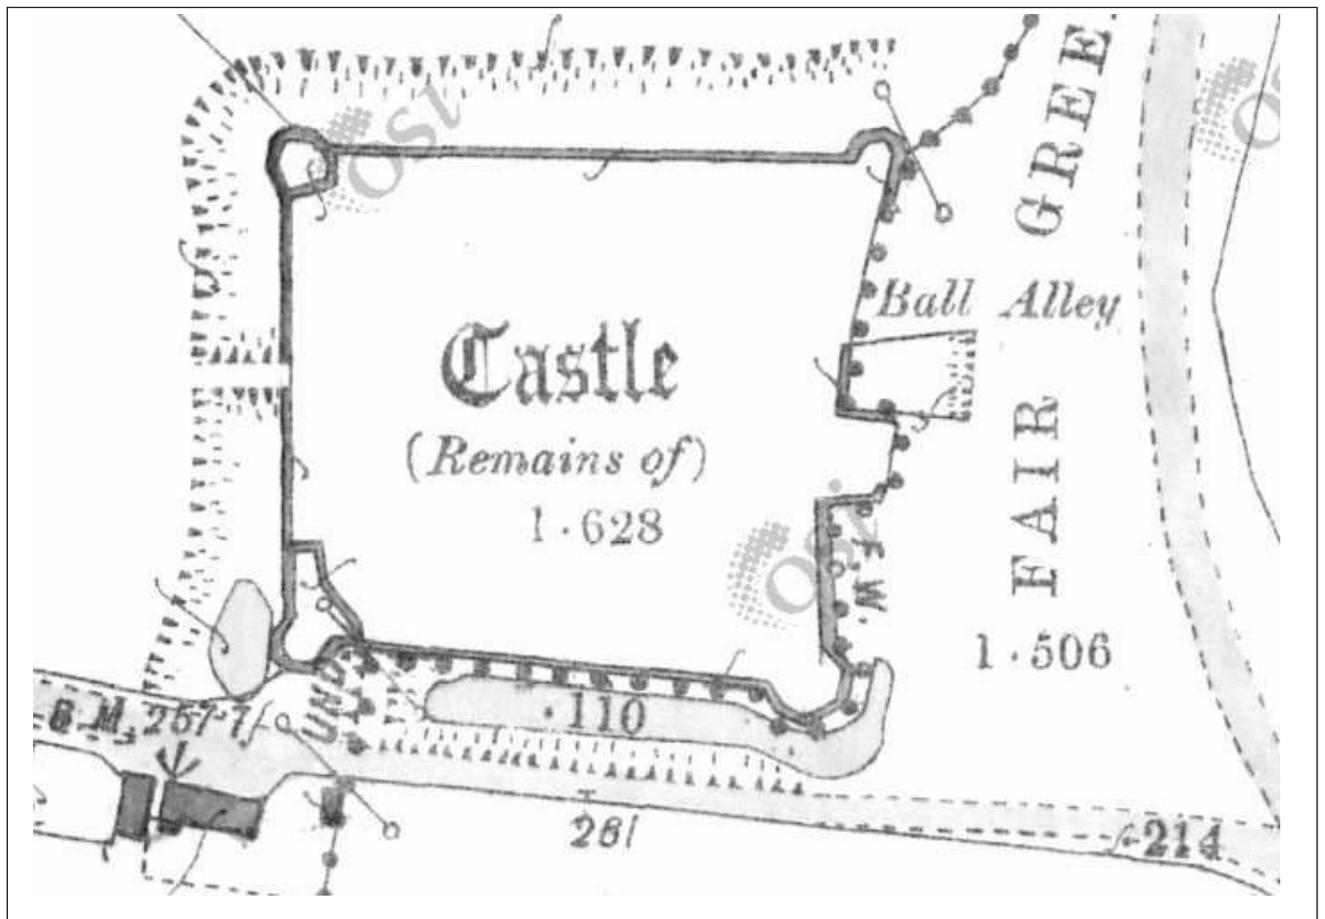
Figure 9: Detail from OS 25 inch/mile showing castle layout recorded in early 1900s

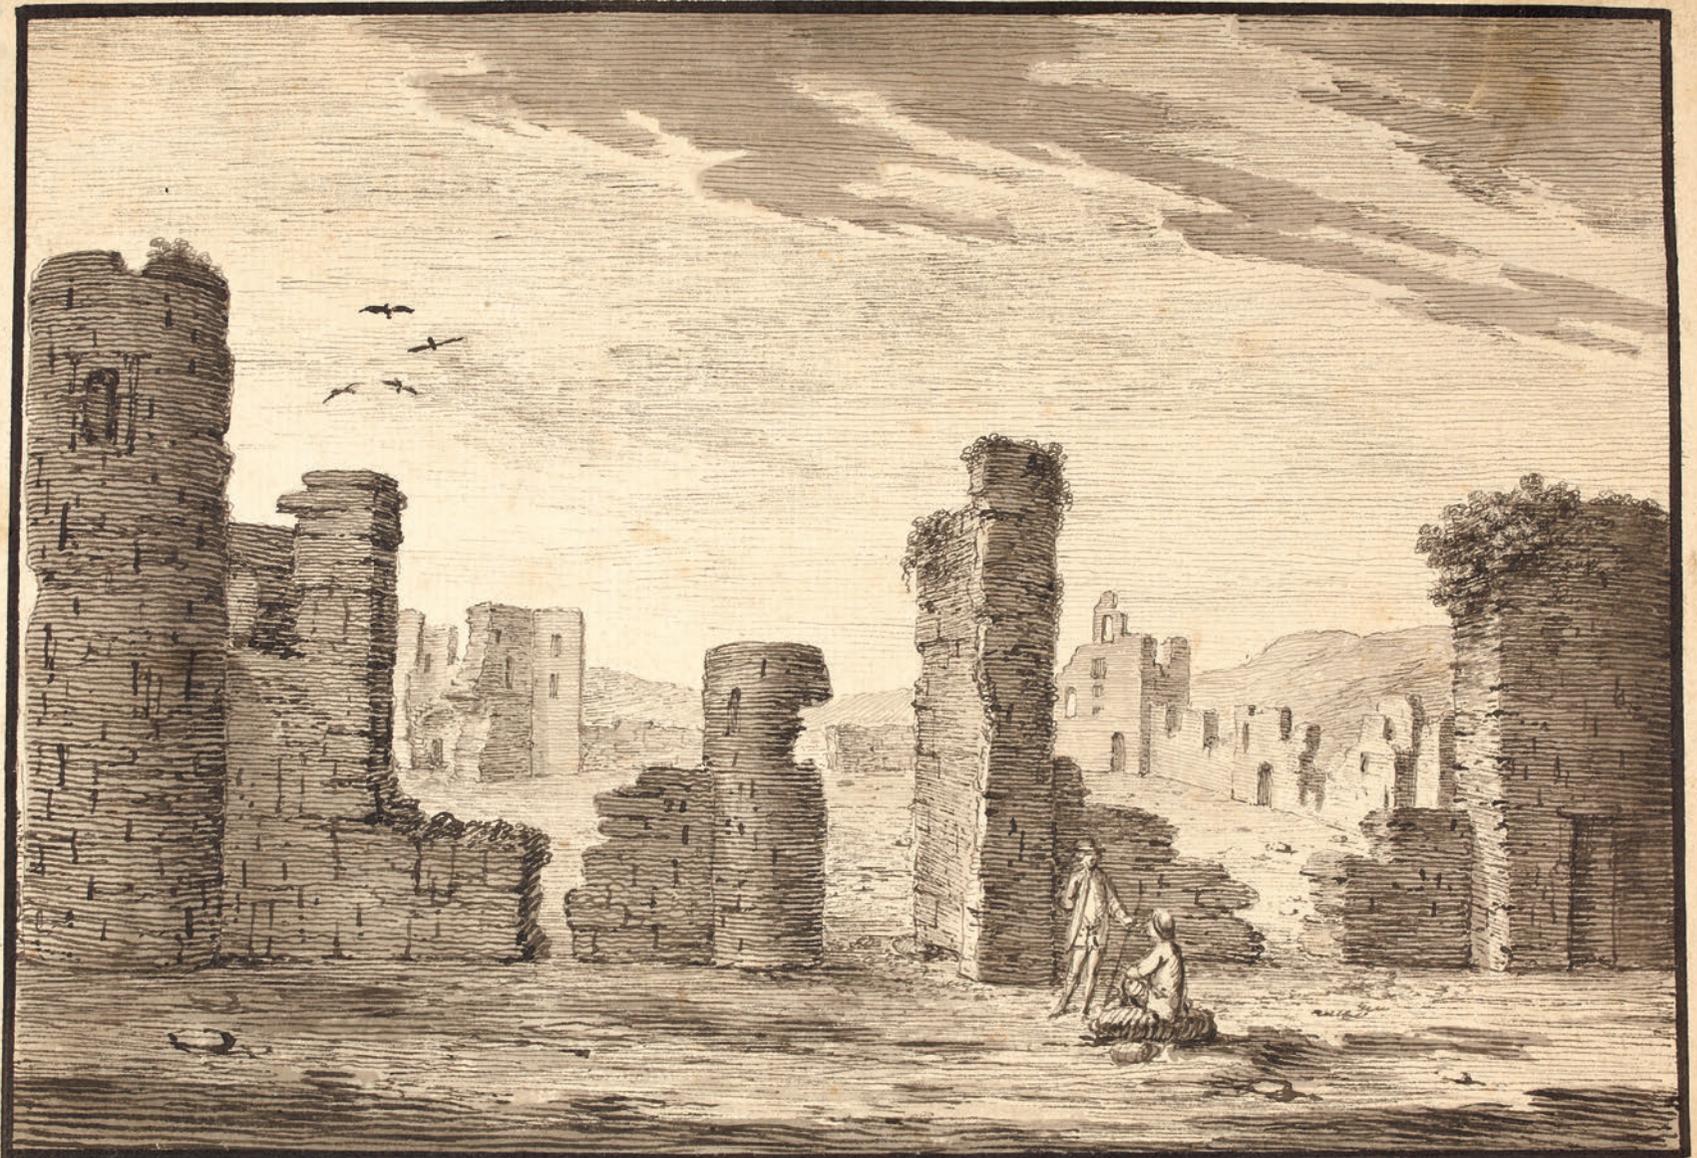
Figure 10: Ballintober Castle, as drawn by Angelo Bigari in 1779.  
The view looks west at the east wall from outside the castle

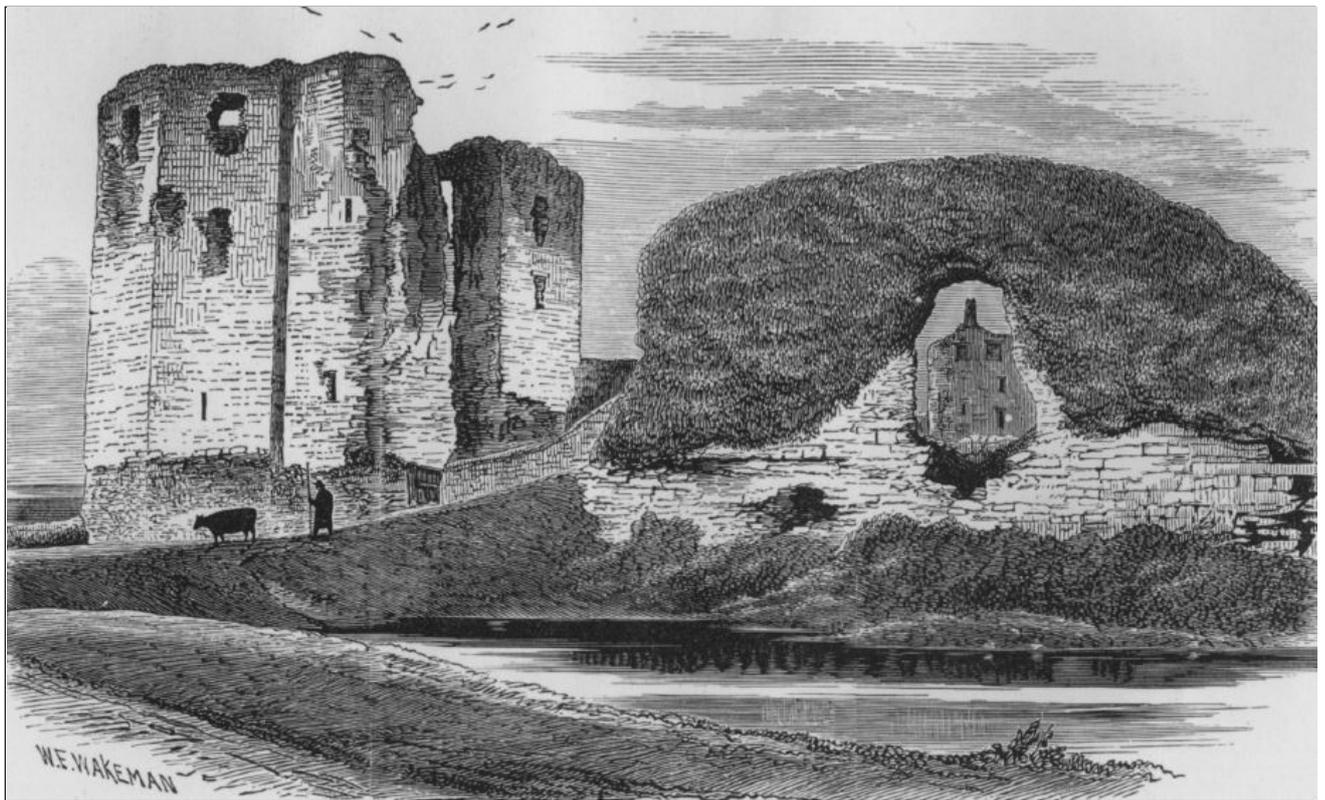
Figure 11: Ballintober Caste, historic images

Top: View of Southwest corner tower by Wakeman.  
 The image is undated but is published by O'Conor Don' in 1899. Note the shattered nature of the base batter on the tower, and the absence of ivy and the visible extent of the stairwell, and the absence of any clear indication of the internal support column that now exists on the north end wall of the tower.  
 The fosse is filled with water, and the causeway across it is exaggerated.

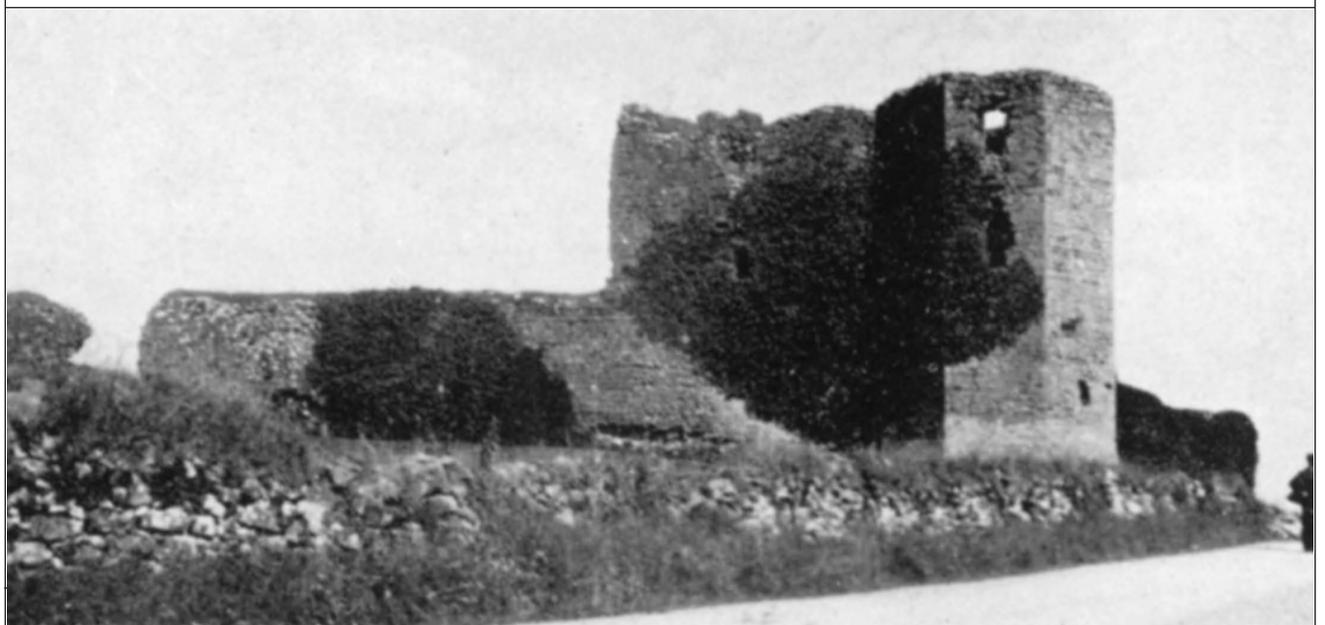
Bottom: View of Southwest corner tower by unknown photographer, published by Fitzpatrick in 1935.  
 Note the base batter has been repaired. The ivy growth that now covers much of the stonework is already established but it is possible to make out details on the residential block, while the fabric of the west perimeter wall north of the tower is exposed.

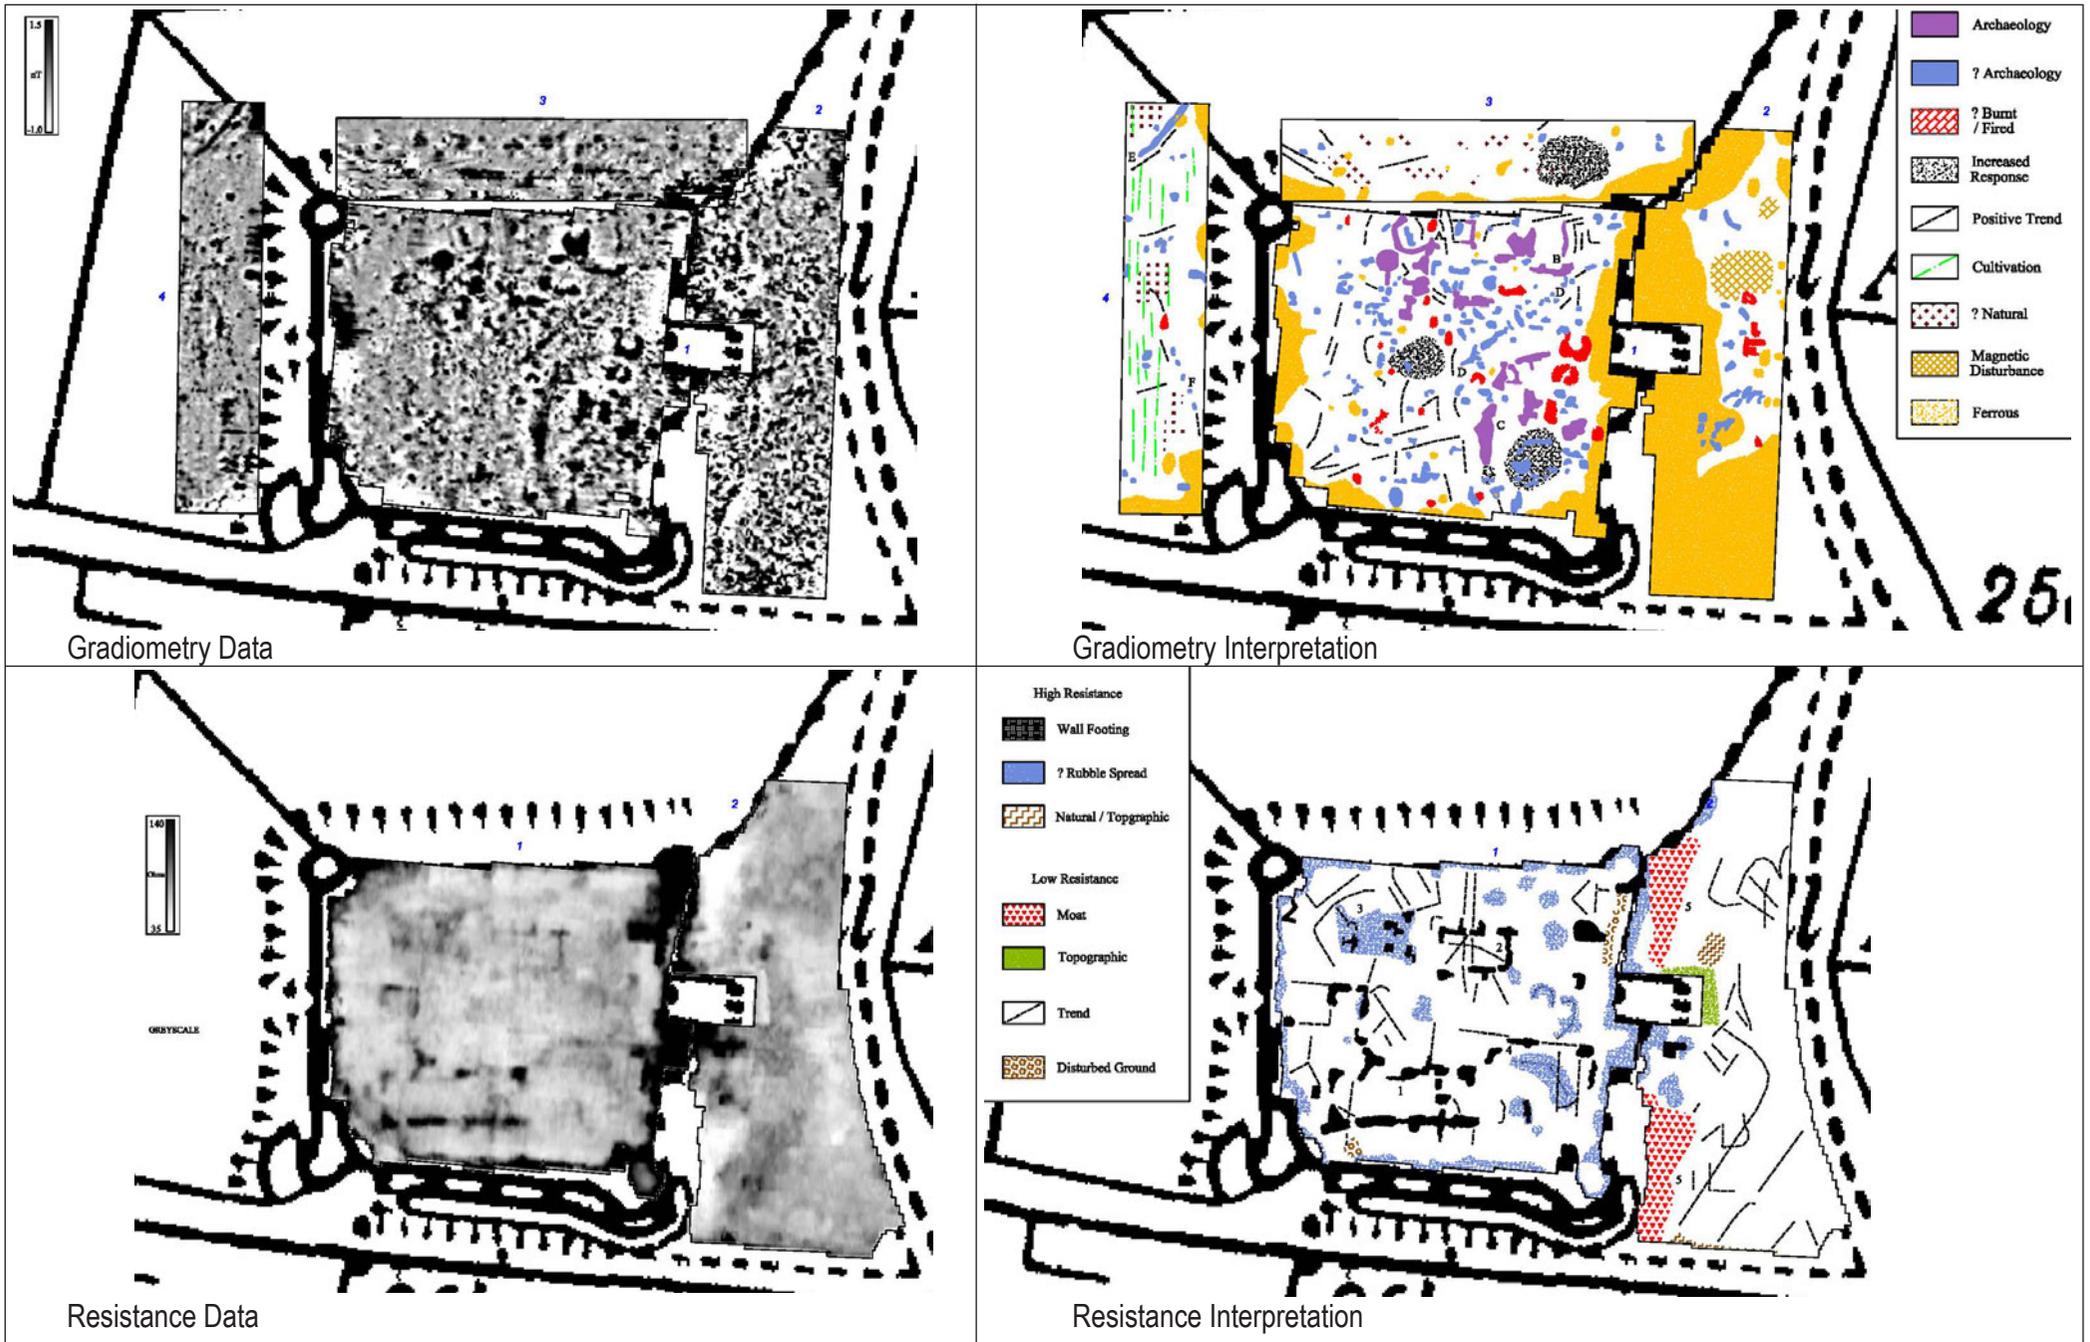
Figure 12: Gradiometry and Resistance Surveys, Ballintober Castle 2008

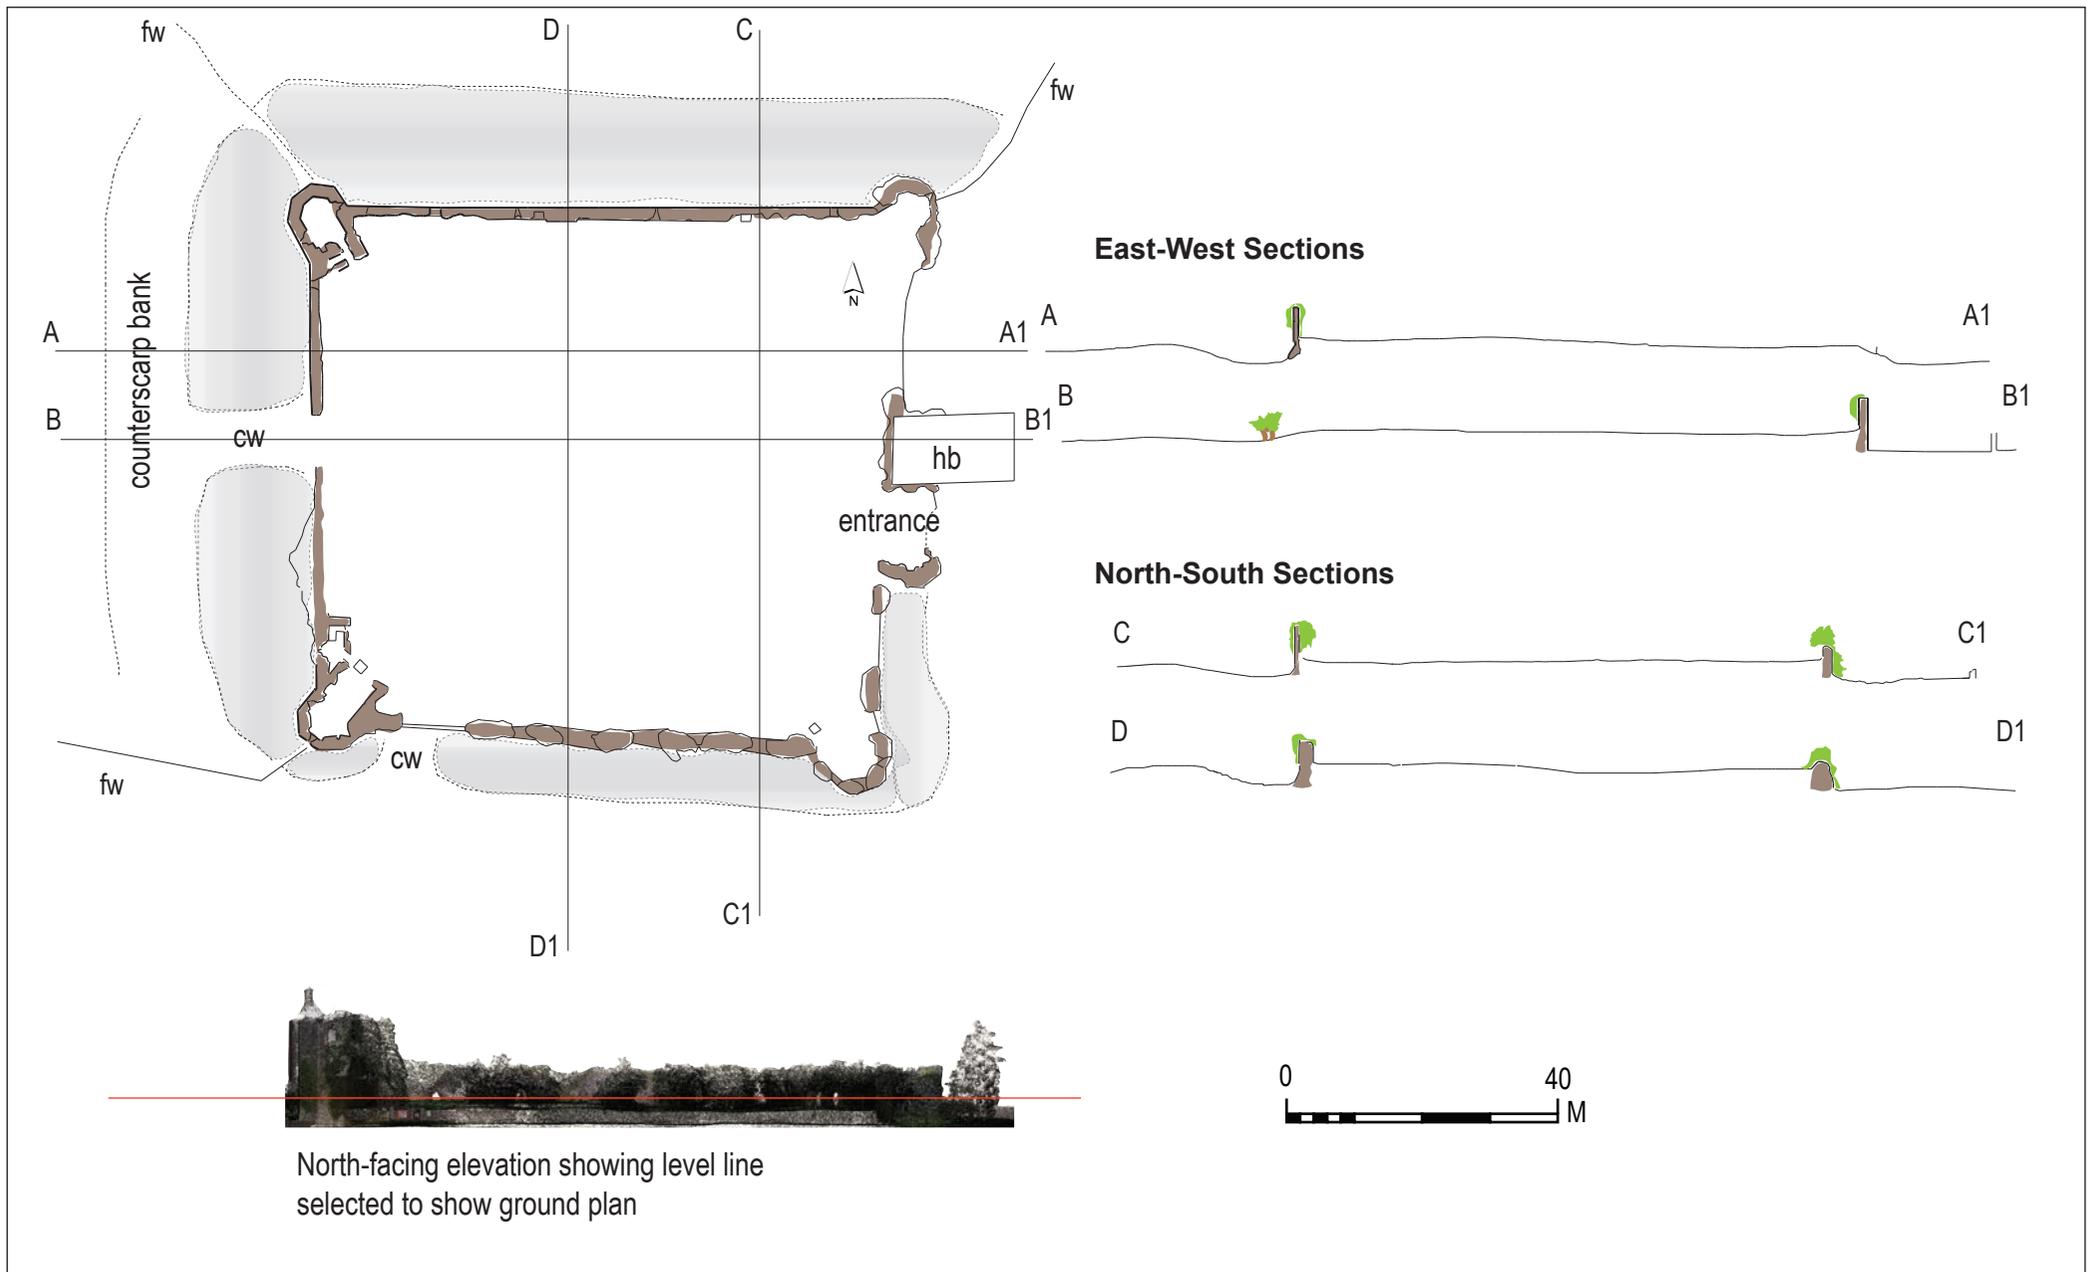
Figure 14: Ballintober Castle, ground plan and sections, 2014

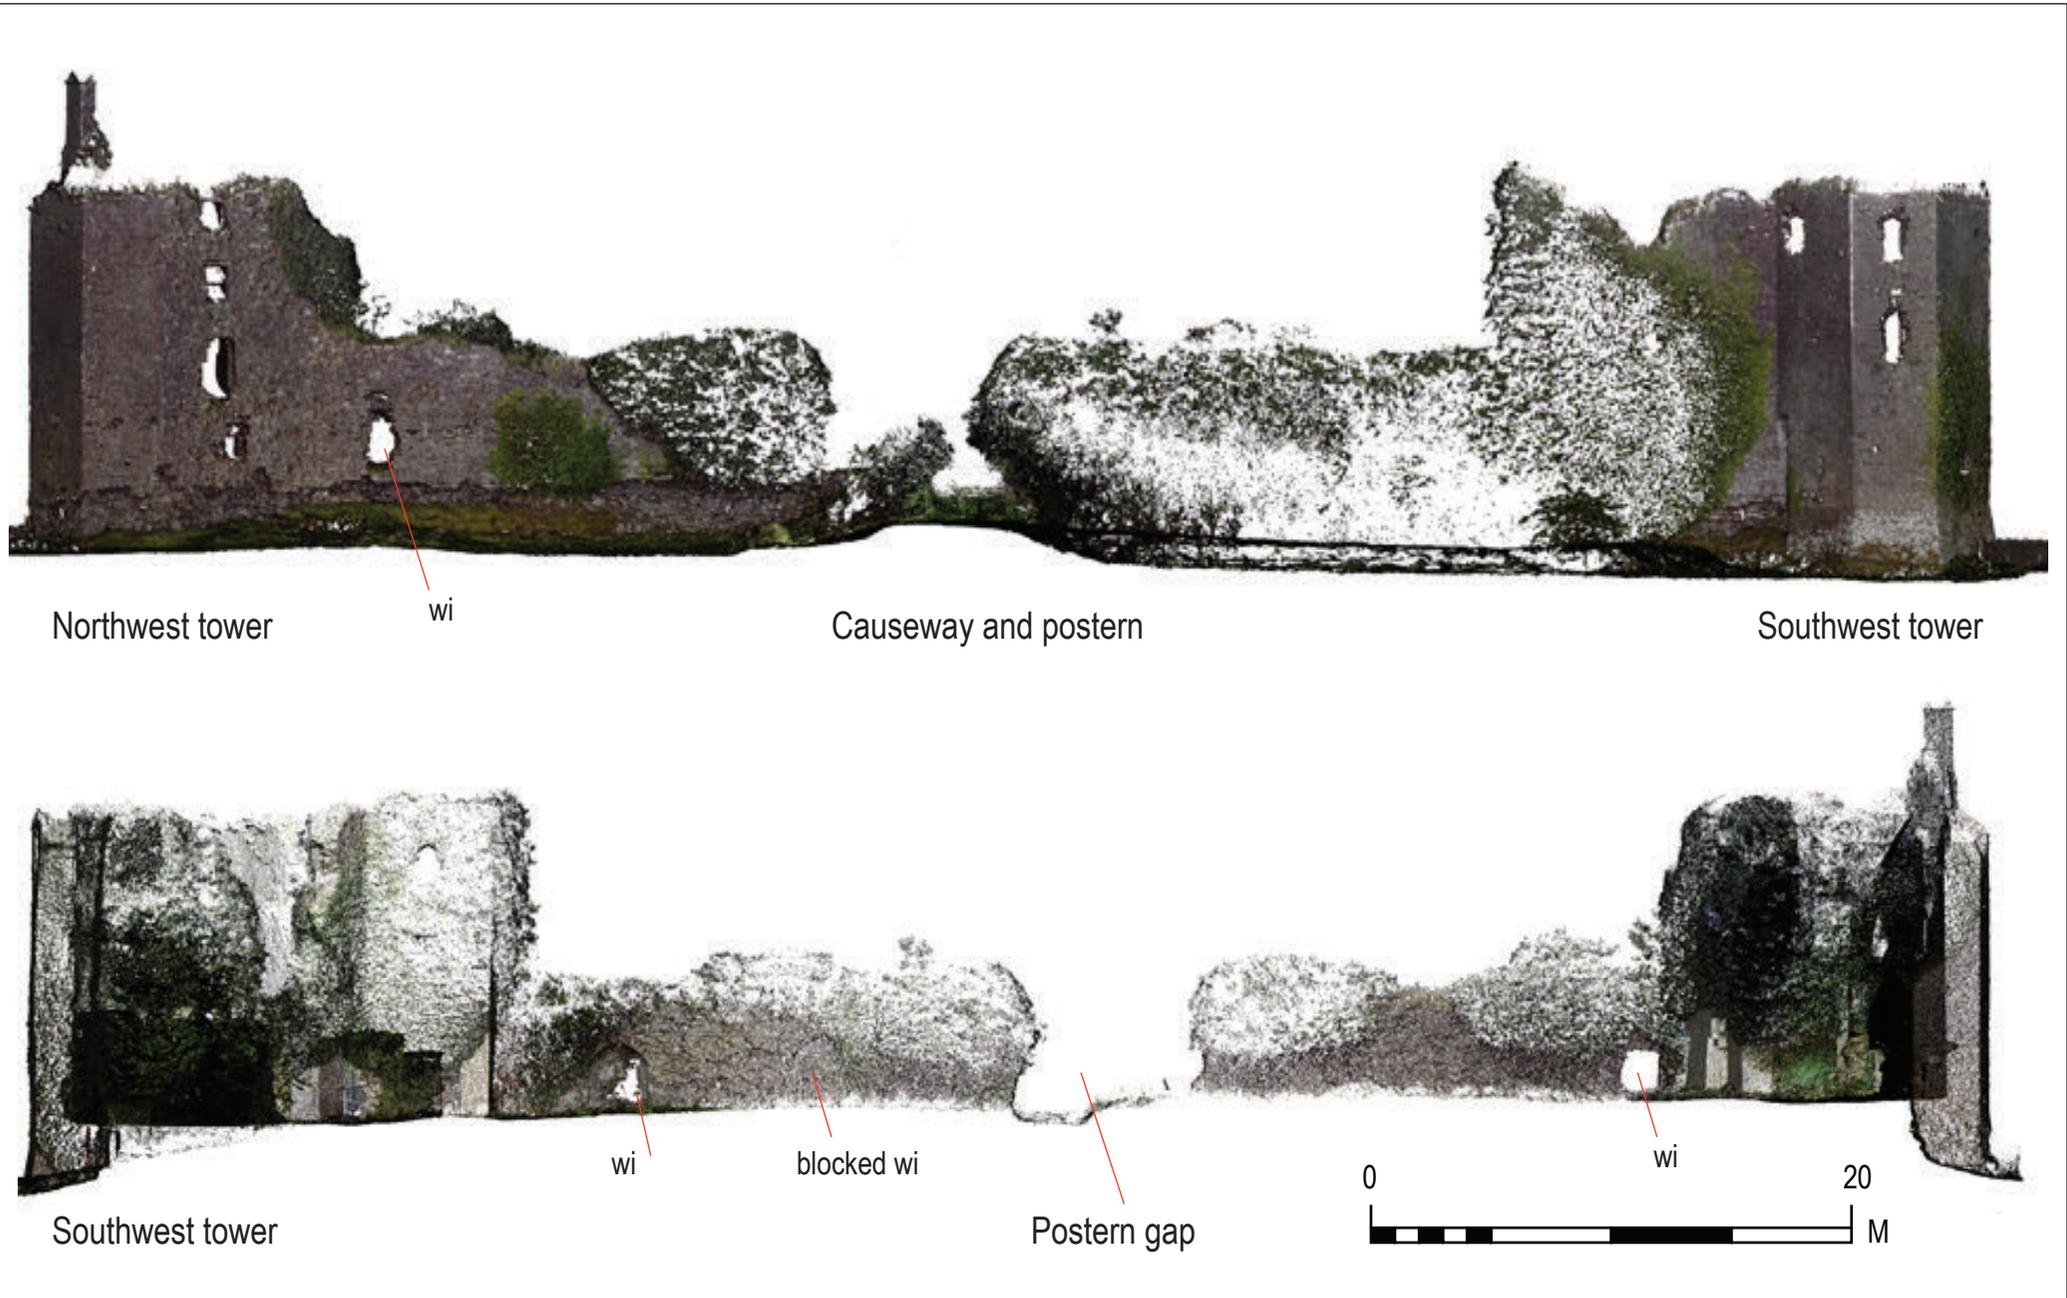
Figure 15: Ortho-images of Castle's west wall, exterior and interior view

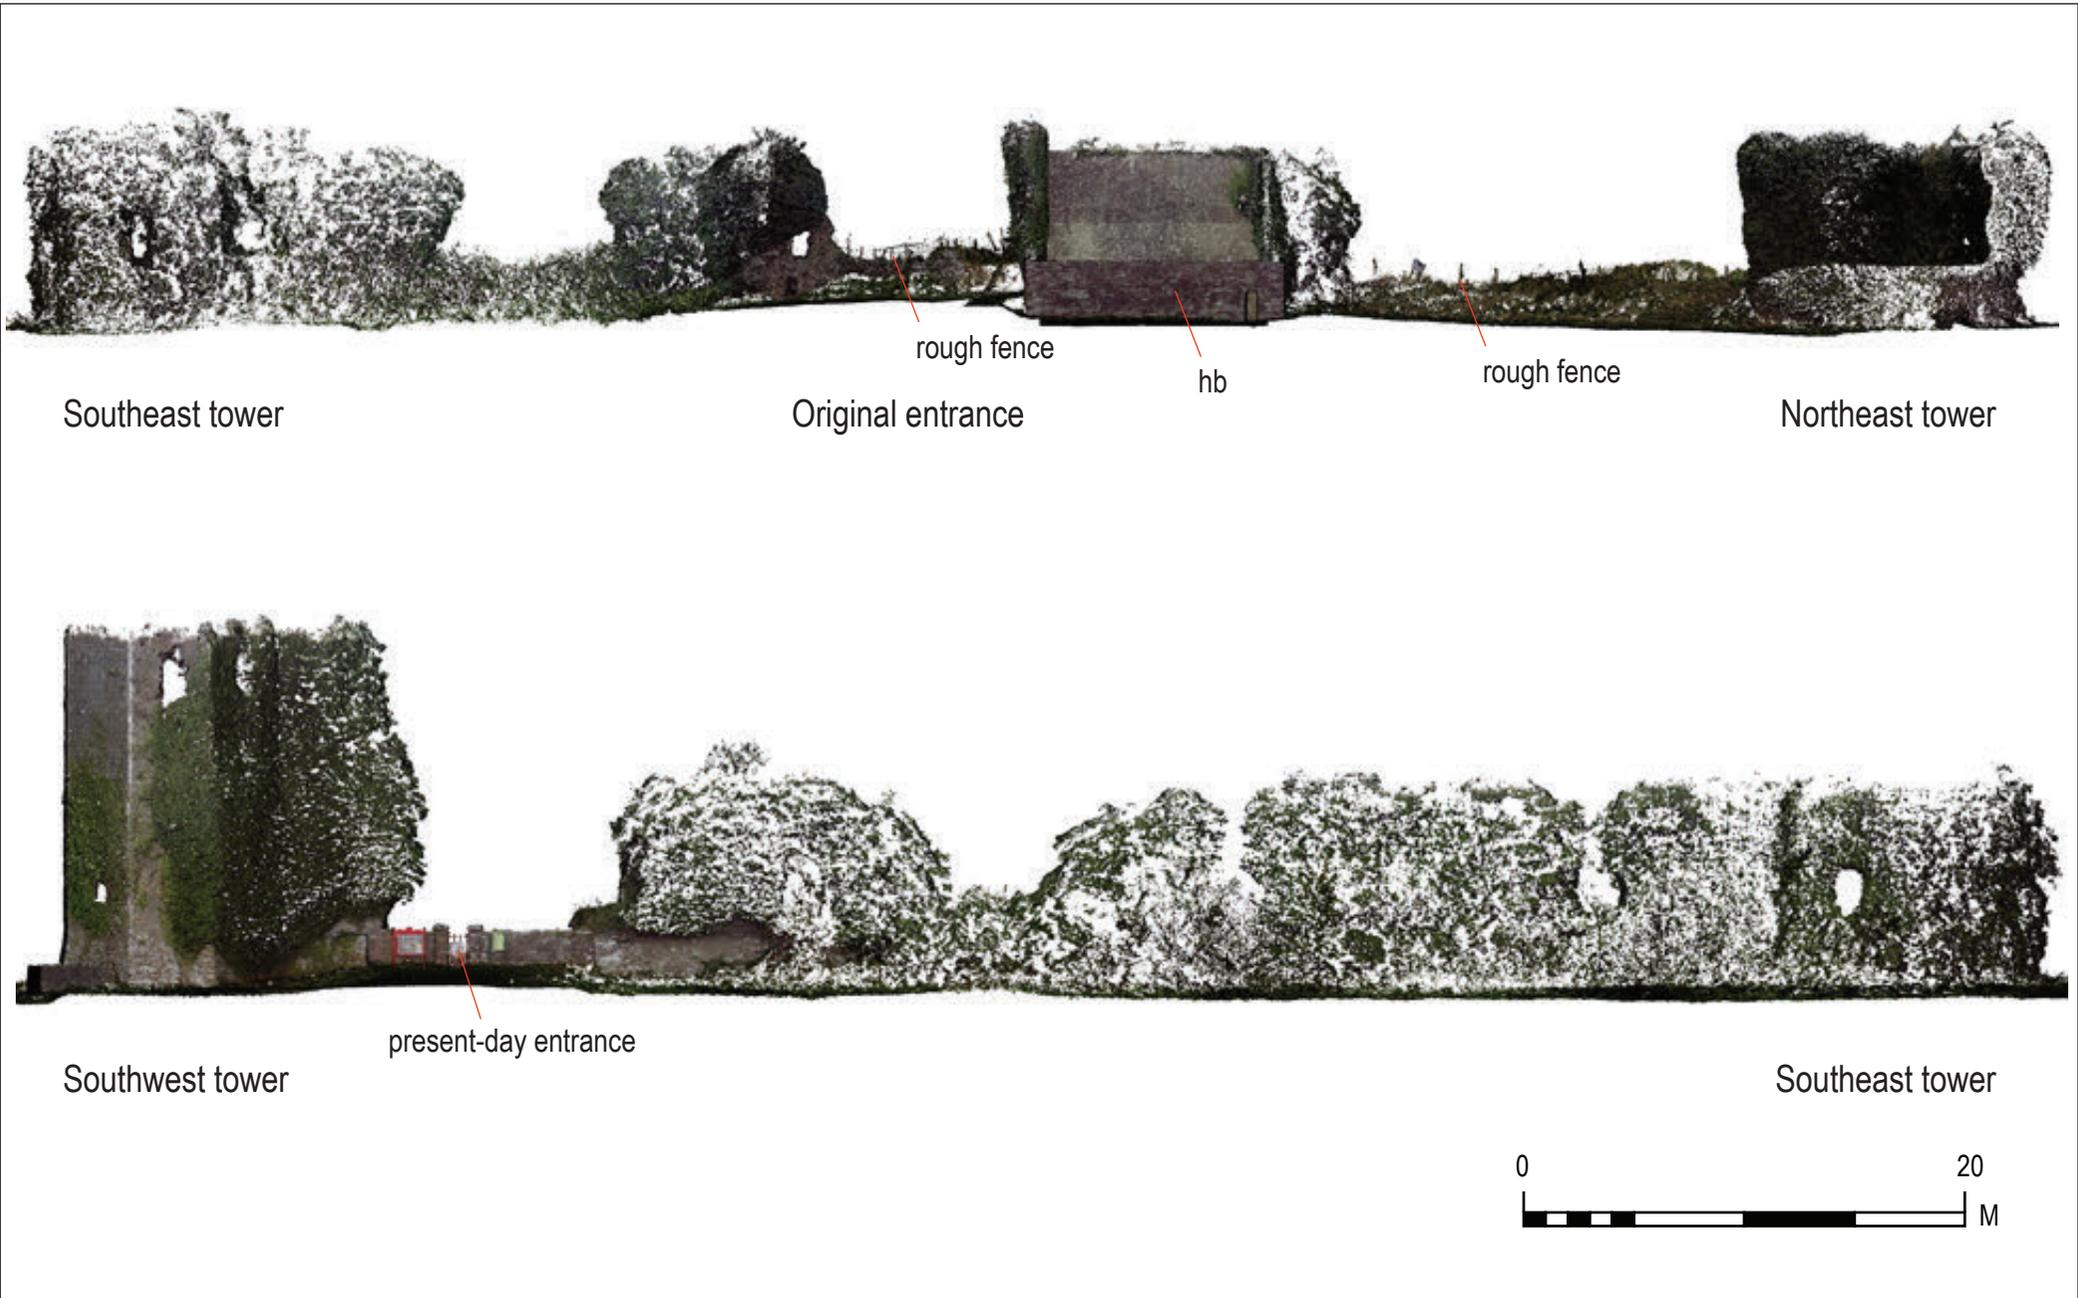
Figure 16: Ortho-images of Castle's east and south walls, exterior view

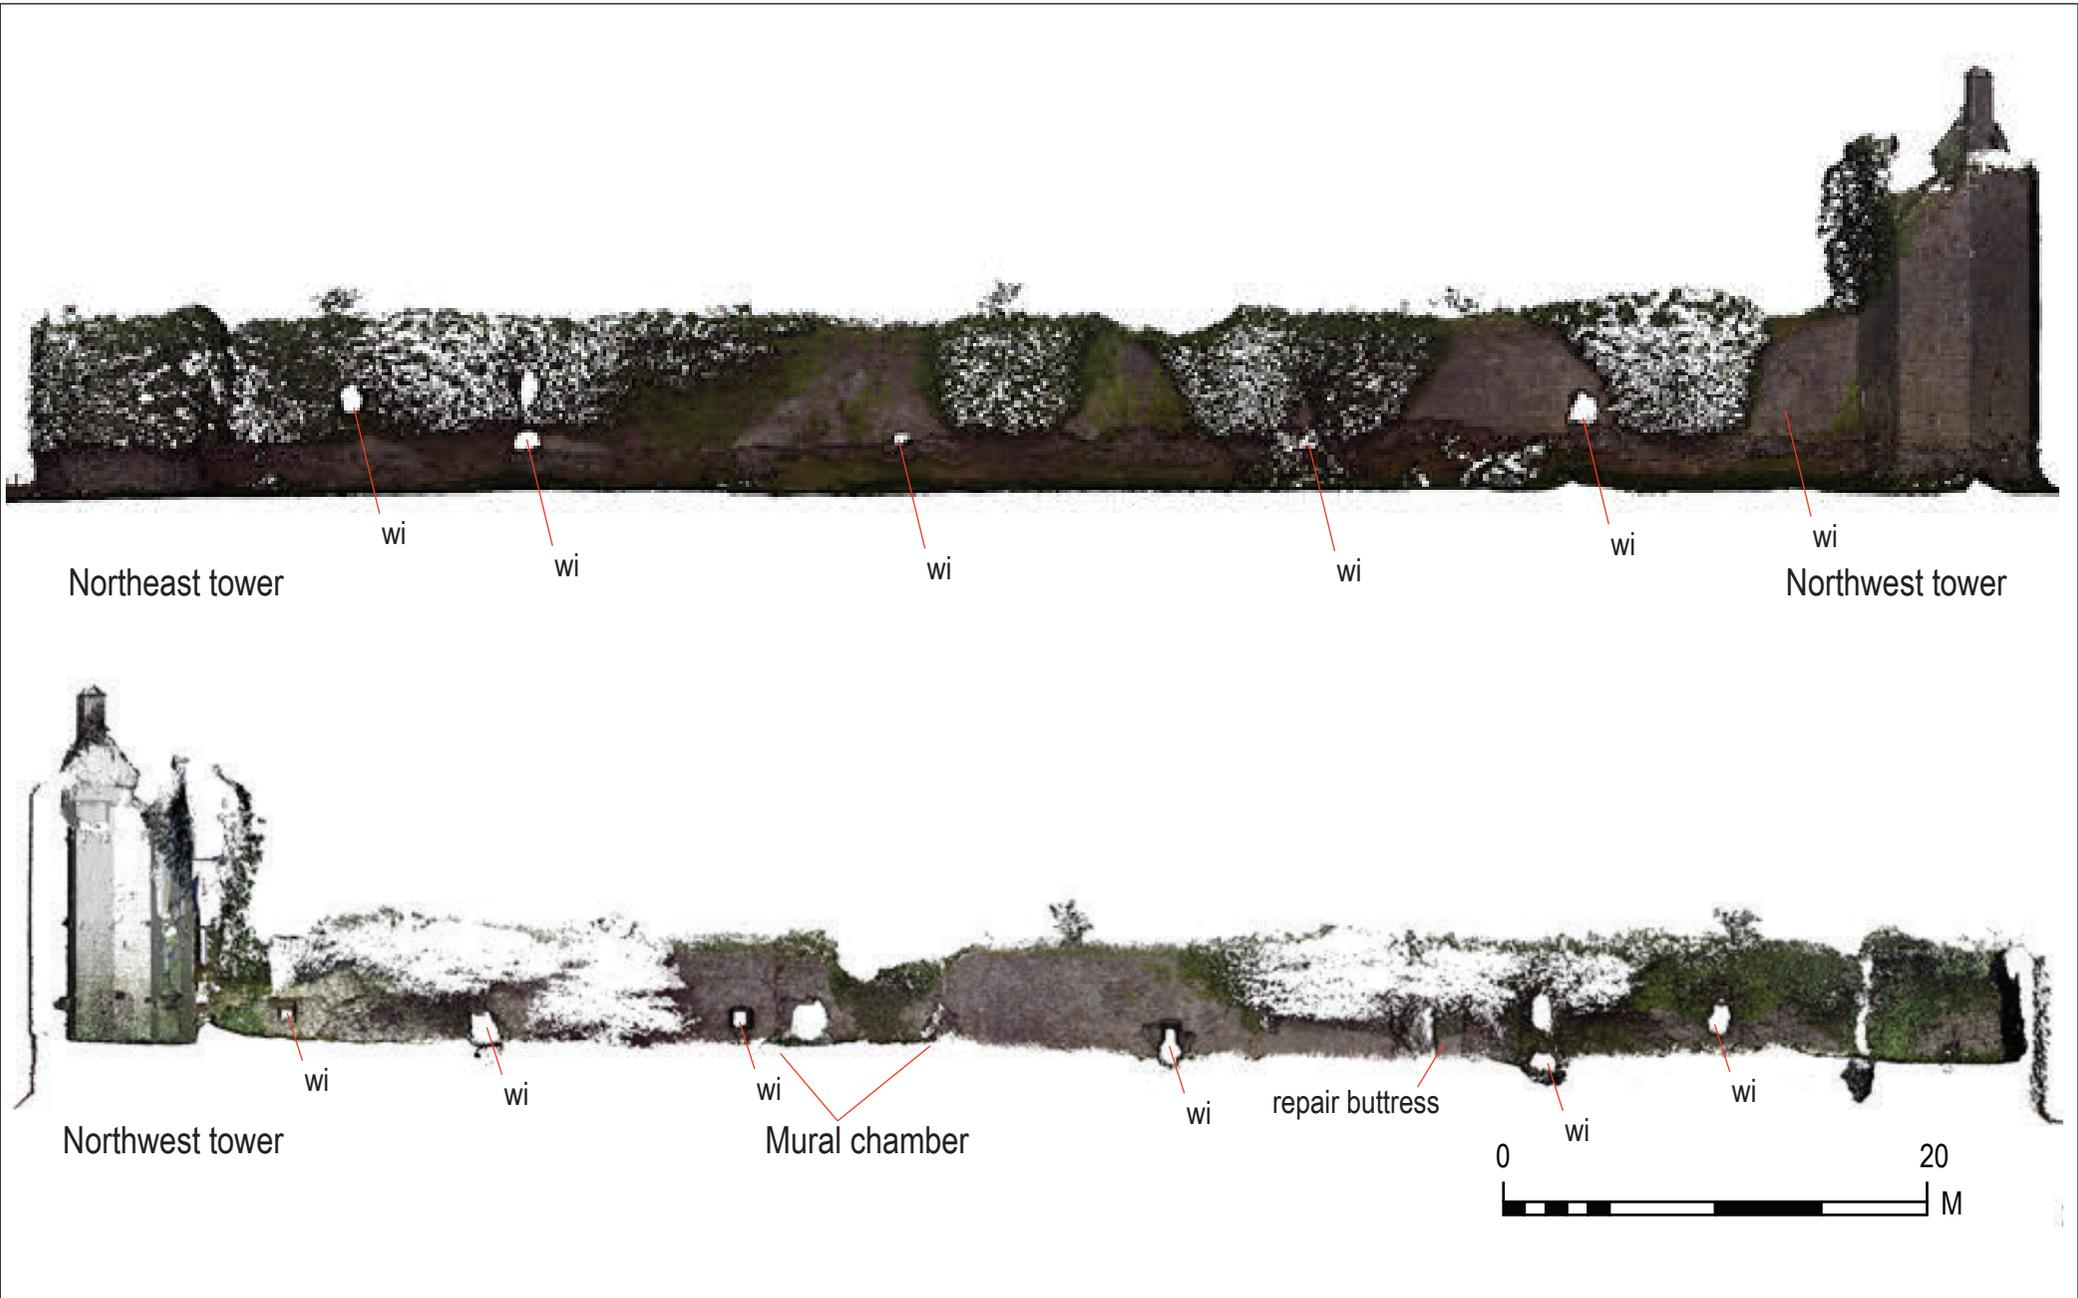
Figure 17: Ortho-images of Castle's north wall, exterior and interior view
